Intel[®] Mobile Celeron[™] Processor at 466 MHz, 433 MHz, 400 MHz, 366 MHz, 333 MHz, 300 MHz, and 266 MHz Specification Update

Release Date: February 2001

Order Number: 244444-022

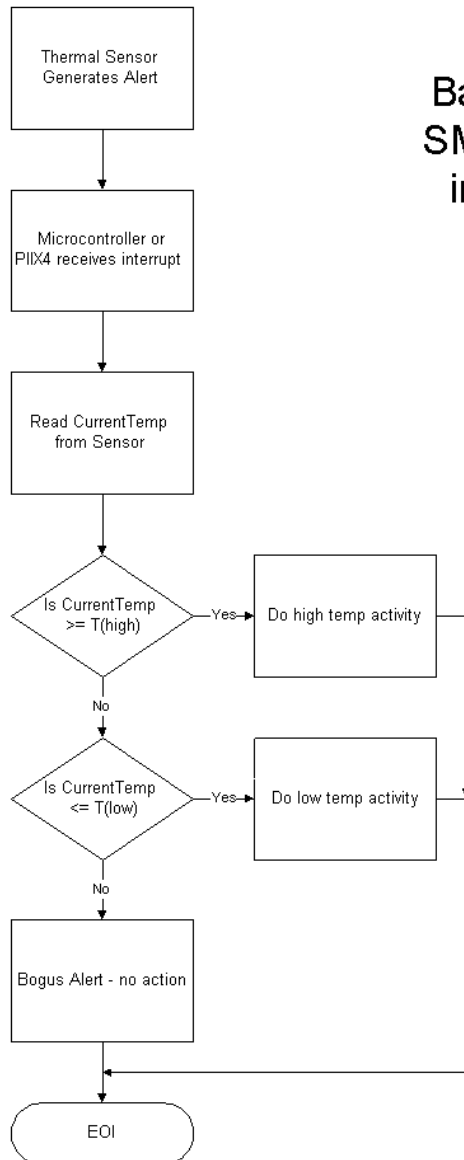
Figure 2. Workaround Flowchart: SMBALERT#-Driven System

H29. Thermal Sensor May Assert SMBALERT# Incorrectly

Problem: The Intel Celeron Processor Mobile Module has a thermal sensor that monitors the processor core's temperature. Please note that desktop systems could have a similar thermal device. The thermal sensor asserts SMBALERT# if the processor temperature exceeds the temperature limits set in the Alarm Threshold Registers (T_{HIGH} , T_{LOW}). It also sets the corresponding Status Register bits to identify the cause of the interrupt. Figure 1 gives one example of the how the SMBALERT# signal could be used in a system.

Implication: There is no system impact from this erratum if temperature polling is used for processor thermal management. If the SMBALERT# interrupt is employed to manage processor thermal sensing, then servicing the false interrupt may result in premature system action depending on the software and hardware implementations used. The rate of the false interrupts is less than the auto-convert rate of the thermal sensor.

1. Before servicing an interrupt from the thermal sensor, read and compare the processor thermal reading with the threshold limits (T_{HIGH} or T_{LOW}). Figures 2 and 3 provide basic flowcharts for the implementation of this workaround in an interrupt driven system.
2. If the firmware implemented polls the Status Register only, then before taking any action, re-read the temperature register and do a comparison with the alarm threshold limits (T_{HIGH} or T_{LOW}) to determine if the value is actually still within the temperature window.
3. Use a temperature polling scheme to monitor the processor temperature.
